MASY SYSTEMS, INC.

Validation Services

Datalogger Electronics Damage from Thermocouple Leakage

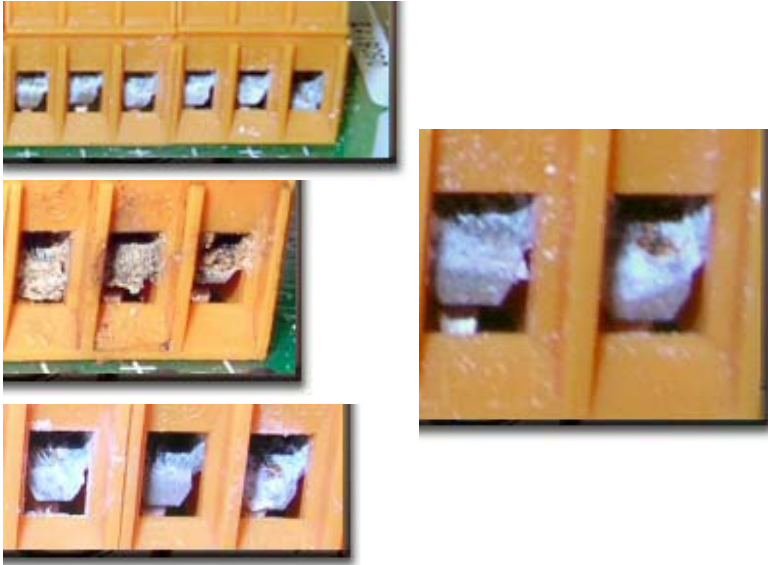
When using thermocouples in the sterilization process, it is imperative to ensure that the steam does not wick into the electronics in the datalogger causing corrosion.

Examples of corroded SIM terminals:

Carefully slice or remove 1/4" from the thermocouple's outer jacket at least 18" away from the SIM (or at the chamber feedthrough), to help prevent liquid from entering and damaging the electronics. **Note:** Even after taking these precautions moisture may still accumulate in the SIM and cause damage.

- To determine the location of the slice on the thermocouple jacket, estimate the distance from the datalogger that your thermocouple is likely to hang down. We normally slice about 18" from the datalogger.
- Once you have your location, lay the thermocouple flat on one side. **Very** carefully, slice the jacket with a skillful slice approximately 1/4 inch long, then flip over and slice through other side, making sure the red and blue wires are not damaged.
- *Slice the jacket in the middle only!* Test your thermocouples after slicing to be sure they are functional. Replace any that were inadvertently sliced.
